**PRELIMINARY ASSESSMENT/
VISUAL SITE INSPECTION**

**HENRY VALVE COMPANY
MELROSE PARK, ILLINOIS
ILD 005 071 741**

FINAL REPORT

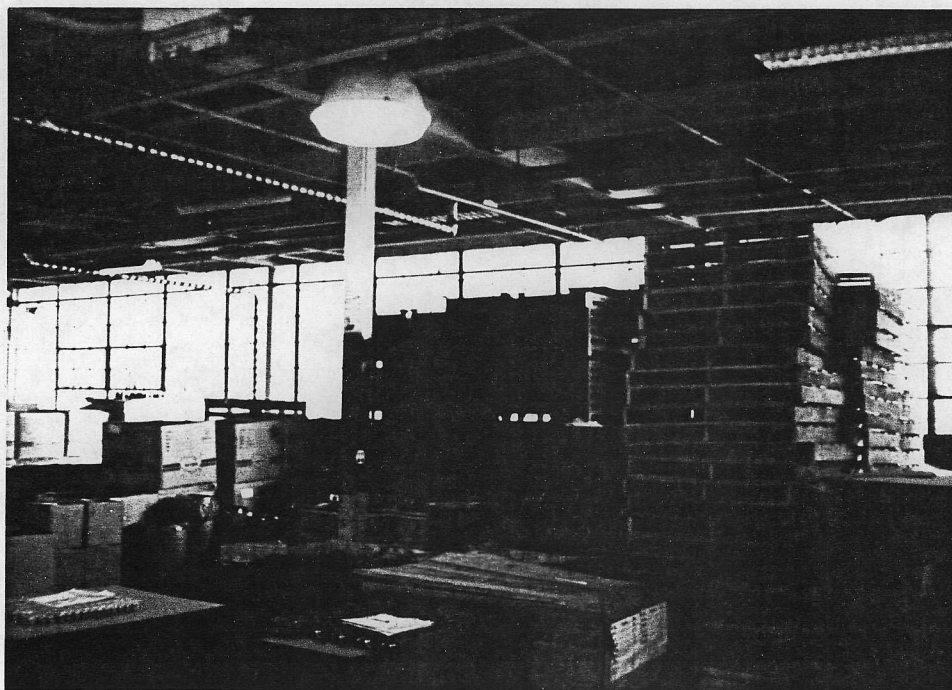
Photograph No. 4

This unit is east of the vapor degreaser, adjacent to the eastern wall of the facility. The size of this area is unknown, but a 1986 IEPA inspection noted the storage of six drums of methylene chloride still bottoms (F001). The unit was not declared in the facility's Part A application, and no further information about the unit was found. (See Photograph 4).

Observations: The unit contained six drums of methylene chloride still bottoms (F001) during an IEPA inspection (IEPA, 1986a). During the VSI on January 27, 1992, there was no hazardous waste in the unit, and it contained wooden pallets and other non-hazardous products. There was no evidence of release and the concrete was in good condition.

Description: Inactive indoor drum storage area (drum storage area #1), against east wall of facility, formerly used for storage of drums of methylene chloride still bottoms. Currently used for storage of non-hazardous product materials.

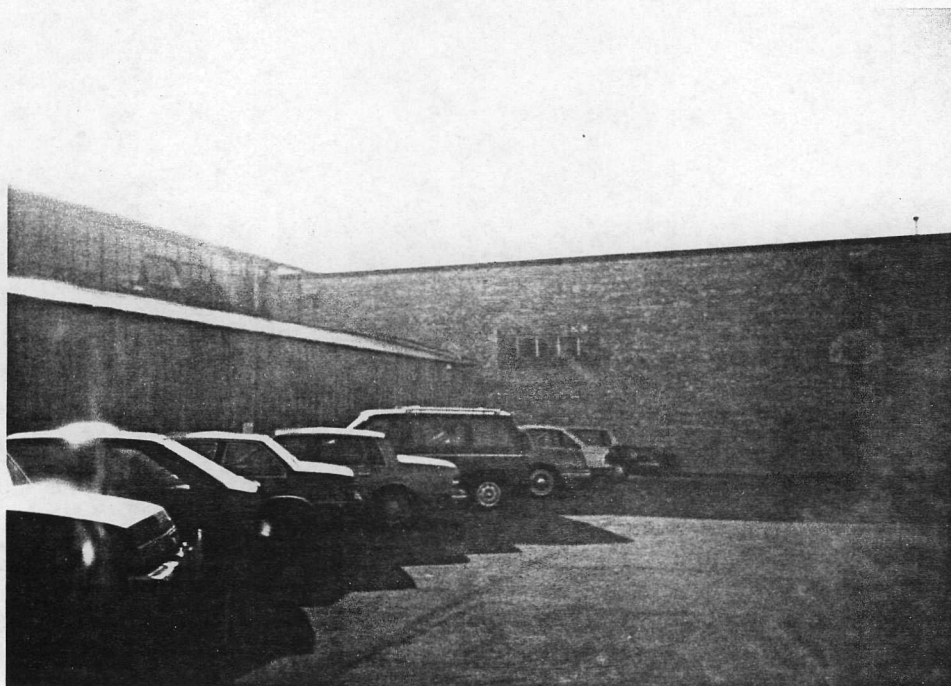
Photograph No. 6

This unit is located outdoors, at the intersection of the sheet metal building and brick building, adjacent to the facility walls. The unit has an asphalt surface. The size of the unit is unknown, but an IEPA inspection indicated that several drums were stored here (IEPA, 1986a). The unit was not declared in the facility's Part A application, and no further information was found (See Photograph 6).

The above referenced IEPA inspection noted storage of seven drums of 1,1,1-trichloroethane, but it is unclear whether this was product or waste. No further information regarding storage of wastes in this unit was found.
